Purpose of SCAPS Investigation

The Rainbow of Free Product at NAS Fallon

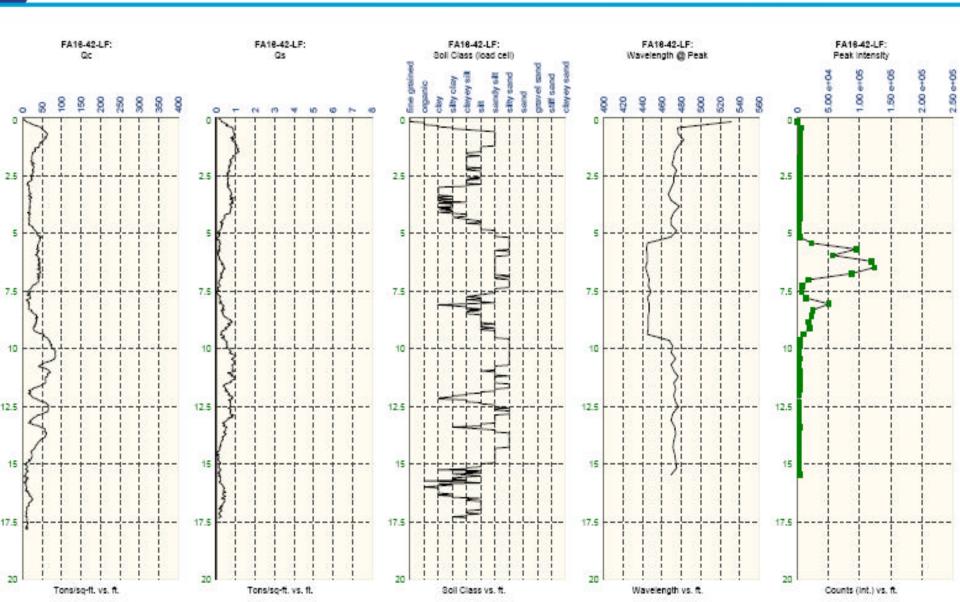
Typical SCAPS Results

- ➤ Direct push rig CPT on tip of probe collects lithology information
- Laser Induced Fluorescence detects hydrocarbons
- ➤ Yields quantitative results that typically correlate to laboratory results
- >Instantaneous results
- **≥20+** locations per day
- ➤ High response may indicate presence of mobile free product
- > May differentiate between types of fuel

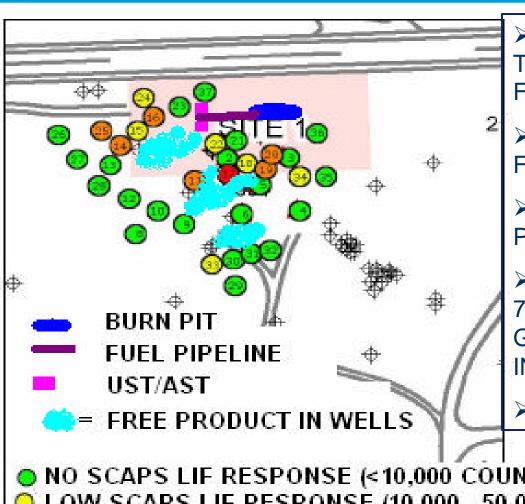
Site 1 – Crash Crew Fire Rescue Training Pit

- >MAXIMUM FREE PRODUCT THICKNESS 0.8 FEET, TYPICAL IS 0.2 FFFT
- >APPROXIMATELY 0.4 ACRES OF FREE PRODUCT
- >APPROXIMATELY 0.9 ACRES OF PETROLEUM-CONTAMINATED SOIL
- ➤ DEPTH OF CONTAMINATION IS 5.5-7 FEET BGS (ONLY AT **GROUNDWATER / VADOSE ZONE INTERFACE**)
- >PREDOMINANTLY JET
- NO SCAPS LIF RESPONSE (<10,000 COUNTS)</p>
- O LOW SCAPS LIF RESPONSE (10,000 50,000 COUNTS)
- MODERATE SCAPS LIF RESPONSE (50,000 100,000 COUNTS)
- HIGH SCAPS LIF RESPONSE (>100,000 COUNTS)

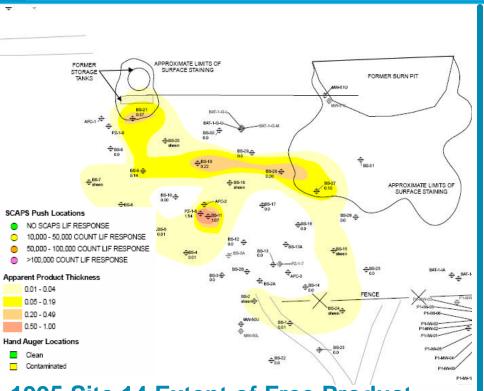
Site 1 Free Product Plume Change 1995 to 2007

0.8 acres of petroleum- contaminated soil

0.3 acres of free product > 0.5 inches

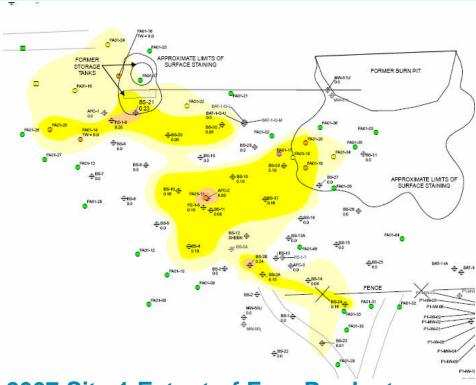
2007 Site 1 Extent of Free Product

0.9 acres of petroleum- contaminated soil

0.4 acres of free product > 0.5 inches

***Extent of free product did not increase—only the extent of the investigation

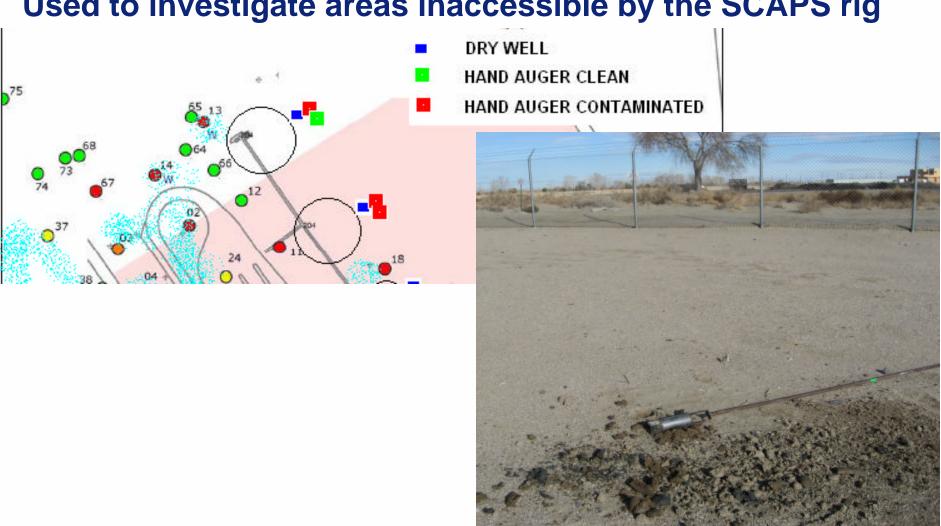
HAVOIS Results (Hand Auger Visual and Olfactory Inspection System)

Used to investigate areas inaccessible by the SCAPS rig

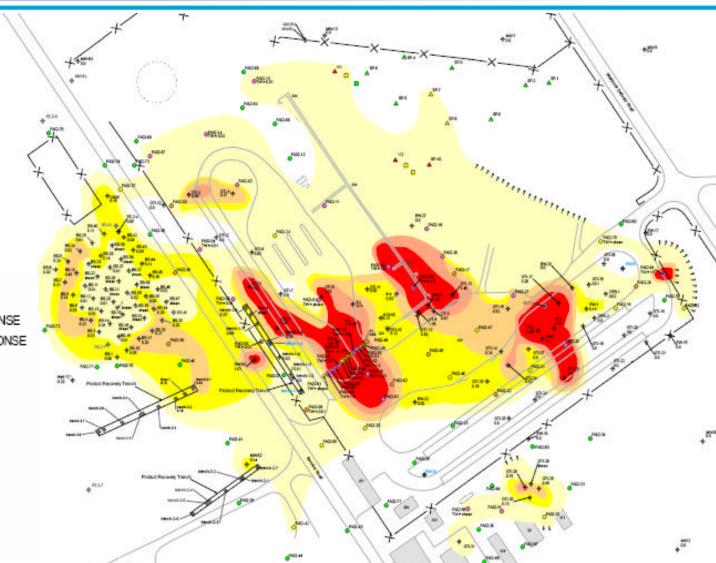
Site 2 – Extent of Free Product

- >FREE PRODUCT THICKNESS VARIES GREATLY ACROSS SITE, UP TO 3 FEET
- ➤ DEPTH OF FREE PRODUCT IS 8 10 FEET BGS—AT GROUNDWATER/VADOSE ZONE INTERFACE (slightly deeper than other sites)
- SMEAR ZONE IS <2 FEET, INDICATING THAT LARGE FLUCTUATIONS IN WATER TABLE LEVES HAVE NOT OCCURRED
- ➤ AREA OF FREE PRODUCT > 0.5 INCH = ~ 6 ACRES
- > AREA OF FUEL-CONTAMINATED SMEAR ZONE SOILS = 14 ACRES
- ➤ HIGHLY VARIABLE GEOLOGY AT SITE—even more than other Fallon sites
- >POTENTIAL NEW SOURCE ON EASTERN SIDE OF SITE 2
- >MULTIPLE JET FUEL SOURCES LIKELY (AVGAS IS PRESENT IN CENTER OF SITE 4)

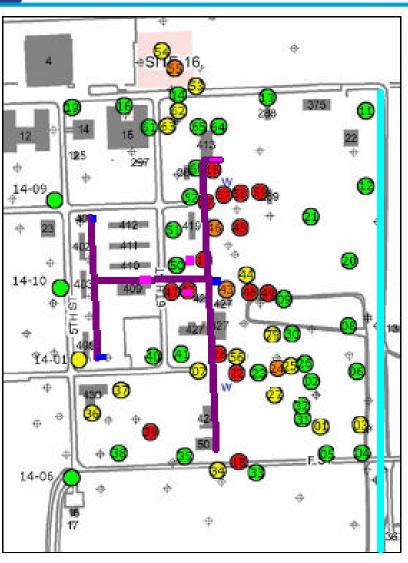
Site 16 – Old Fuel Farm

- DRY WELL
- FUEL OIL PIPELINE
- UST/AST
- E4X DRAIN
- ➤ The Old Fuel Farm is only a minor source of contamination
- The fuel oil pipeline (and associated drywells and tanks) appears to be the major source of Site contamination
- ➤ Potential area of petroleum-contaminated smear zone soil is ~16 acres
- ➤Only one well (RW-16-1) exceeds 0.5-inch free product standard
- Free product and contaminated soil is at the groundwater / vadose zone interface (5 − 7 feet bgs)

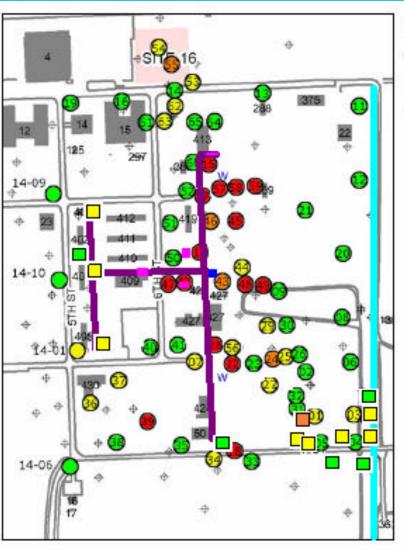
Site 16 Hand Auger Results

- DRY WELL
- FUEL OIL PIPELINE
- UST/AST
- E4X DRAIN
- HAND AUGER CLEAN
- HAND AUGER STAINING
- HAND AUGER VISIBLE PRODUCT
- NO SCAPS LIF RESPONSE (<10,000 COUNTS)
- LOW SCAPS LIF RESPONSE (10,000 50,000 COUNTS)
- MODERATE SCAPS LIF RESPONSE (50,000 100,000 COUN
- HIGH SCAPS LIF RESPONSE (>100,000 COUNTS)

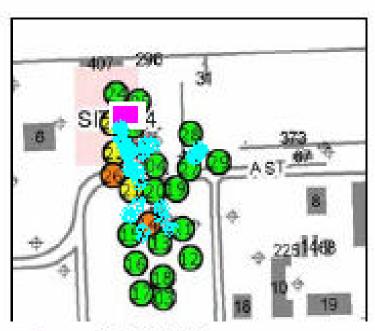
Site 14 – Old Vehicle Maintenance Shop

>SCAPS observations:

- ➤ Apparent free product thickness 0.1 to 1.0 feet
- ➤ Contamination only at smear zone (5.5 to 7.5 feet bgs)
- ➤ Gasoline (with small jet fuel / diesel component)

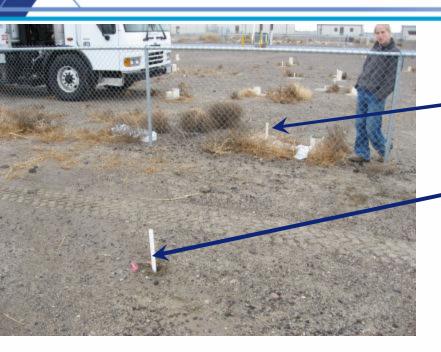
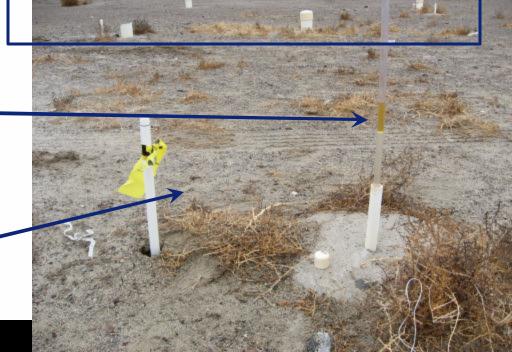
GEOLOGY DICTATES FREE PRODUCT OCCURRENCE AND MIGRATION

1 FOOT OF PRODUCT IN THIS WELL (P3-MW-10 at Site 14)

NO SCAPS LIF RESPONSE HERE
NO SHEEN IN WELL
LABORATORY RESULTS WERE ND

0.4 FOOT OF PRODUCT IN THIS WELL (P3-MW-10 at Site 14)

NO FREE PRODUCT IN THIS WELL

MODERATE SCAPS RESPONSE

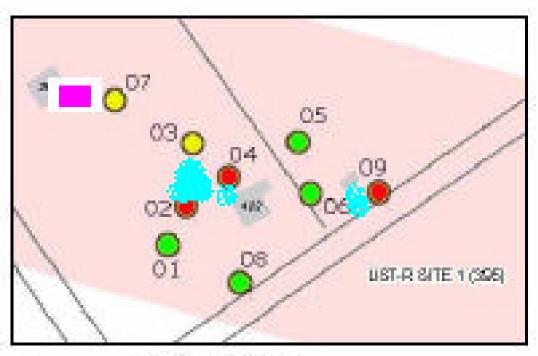
UST 395

SCAPS observations:

- Only 9 pushes --Investigation incomplete nature and extent not defined
- ➤ Diesel fuel (with traces of gasoline)

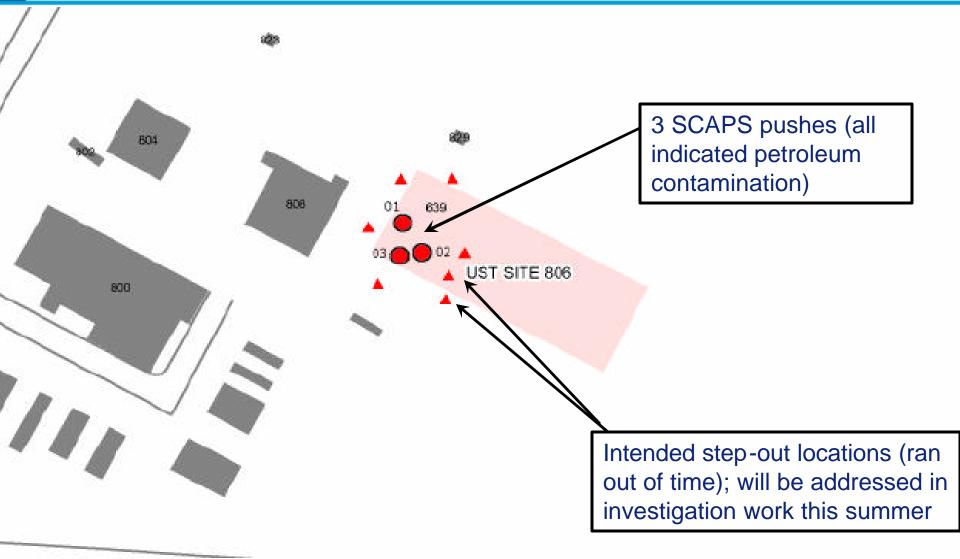
UST 806

>SCAPS observations

- ➤ Only 3 pushes –Investigation incomplete—nature and extent not defined
- ➤ Fuel oil
- ➤ Two USTs removed in 1992
- Two ASTs removed in 2002
- ➤ Piping also a source of contamination

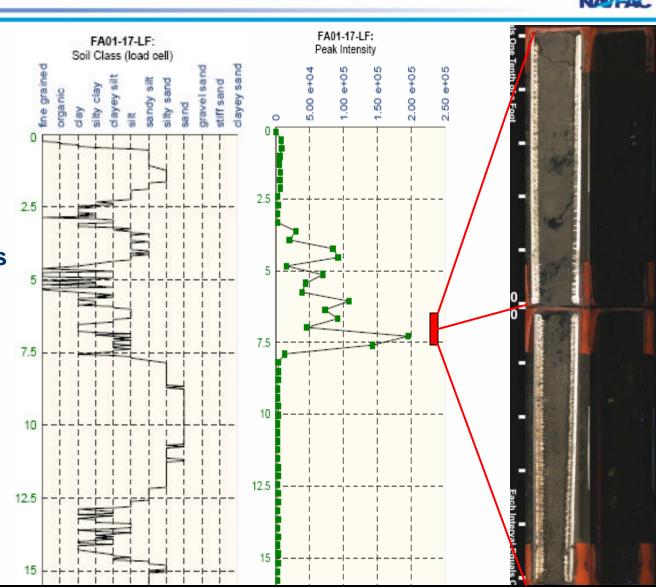
Comparison of Site 1 Core to SCAPS and Laboratory Results

Site 1, SCAPS 17

<u>Laboratory Results:</u>
140 mg/kg TPH-Gasoline
40 mg/kg TPH-Diesel

SCAPS LIF results: 50,000 to >250,000 counts

UV Light Photography: No response

Soil type: Clay to silt

Temporary Well: Not installed

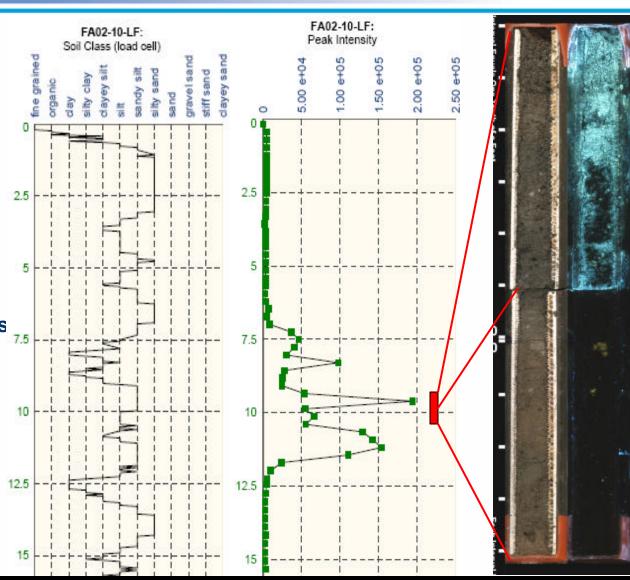
Comparison of Site 2 Cores to SCAPS and Laboratory Results

<u>Laboratory Results:</u>
360 mg/kg TPH-Gasoline
ND (<13 mg/kg) TPH-Diesel

SCAPS LIF results:

50,000 to >250,000 counts

UV Light Photography:

Large response 9.4 to 9.9 ft bgs No response 9.9 to 10.4 feet

Soil Type:

Sandy silt

Temporary well:
Sheen initially,
3 feet after 2 months

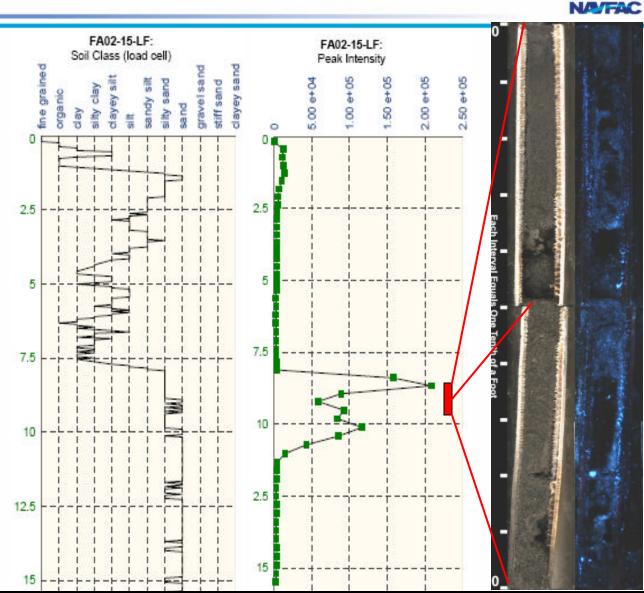
Comparison of Site 2 Cores to SCAPS and Laboratory Results

Site 2, SCAPS 15

Laboratory Results:Not analyzed

SCAPS LIF results: 60,000 to 200,000 counts

UV Light Photography: Moderate response

Soil Type: Sand/silty sand

Temporary Well:
1.93 feet of free product

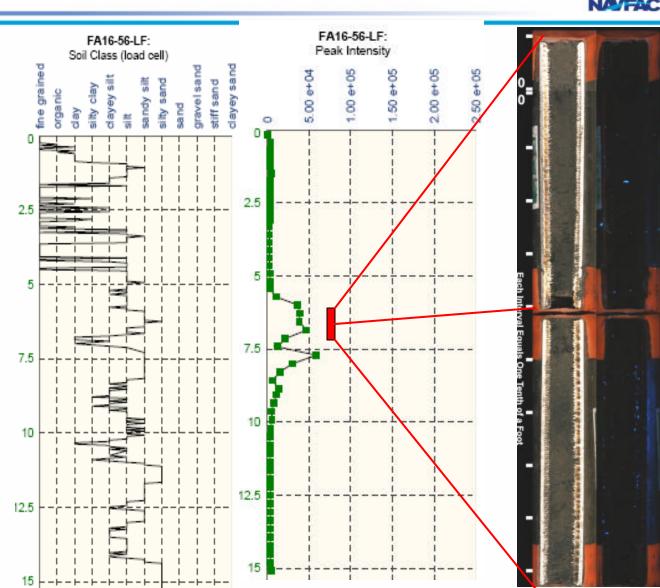
Comparison of Site 16 Cores to SCAPS and Laboratory Results

Site 16, SCAPS 56

<u>Laboratory Results:</u>
45 mg/kg TPH-Gasoline
1,200 mg/kg TPH-Diesel

SCAPS LIF results: 20,000 to 50,000 counts

UV Light Photography: Light response

Soil type: Clay to sandy silt

Temporary Well: No sheen

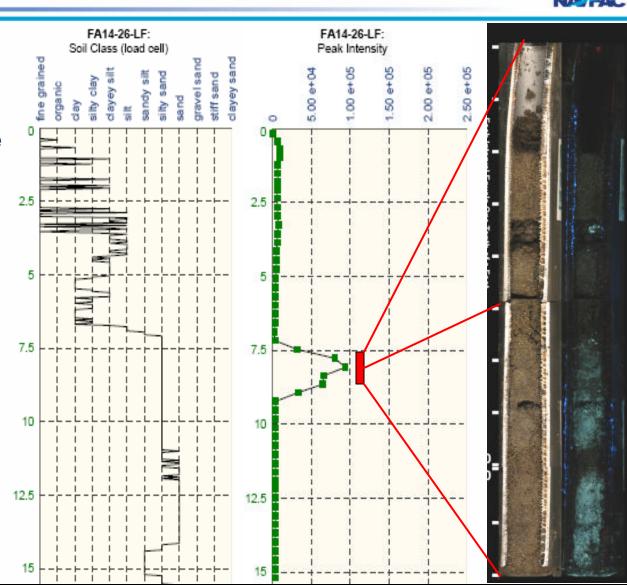
Comparison of Site 14 Core to SCAPS and Laboratory Results

Site 14, SCAPS 26

<u>Laboratory Results:</u>
26,000 mg/kg TPH-Gasoline
7,700 mg/kg TPH-Diesel

SCAPS LIF results: 60,000 to 100,000 counts

UV Light Photography: Light response

Soil type: Silty sand

Temporary Well: 0.21 feet

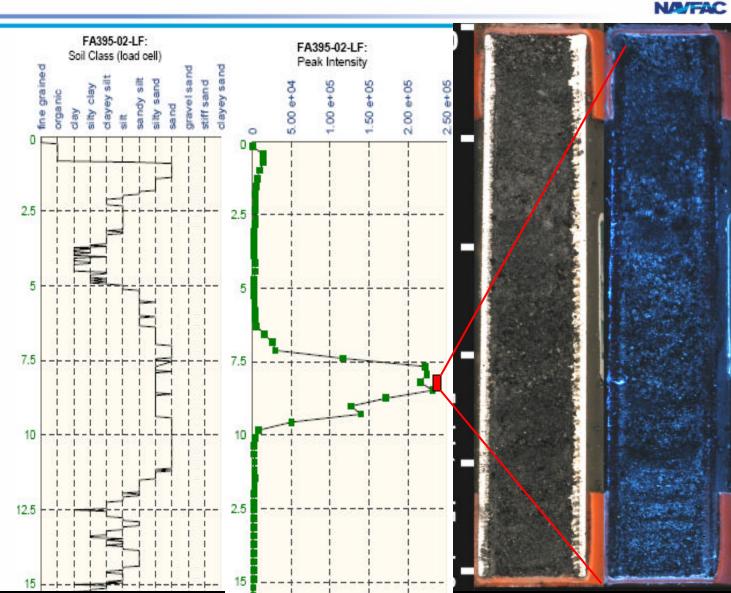
Comparison of UST 395 Core to SCAPS and Laboratory Results

<u>UST 395, SCAPS 02</u>

Laboratory Results: 37 mg/kg TPH-Gasoline 37,000 mg/kg TPH-Diesel

SCAPS LIF results:
>250,000 counts

UV Light
Photography:
Heavy response

Soil type: Silty sand

Temporary Well: Not installed
